Foredune Response to Storm Erosion and the Role of Vegetation in Recovery

Virtue, Christopher J., Foredune Response to Storm Erosion and the Role of Vegetation in Recovery, BEnvSc Hons, School of Earth & Environmental Science, University of Wollongong, 2017.
<https://ro.uow.edu.au/thsci/147>

Thesis

BEnvSc Hons

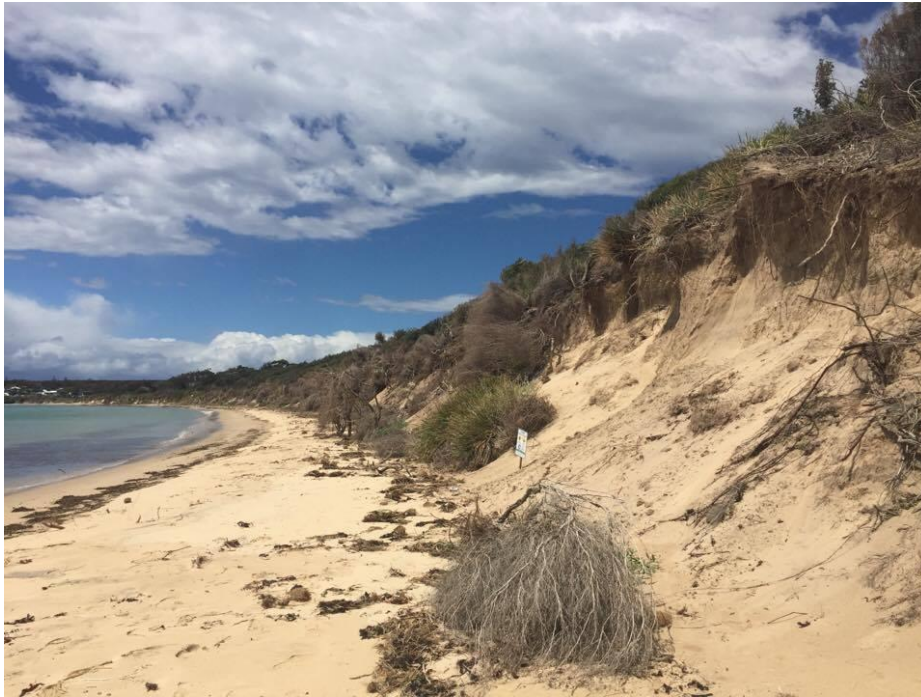
Figure 6 Erosional Scarp at Currarong in Jervis Bay NSW (Taken by Author)

In summary, the event produced significant coastal erosion and inundation due to the slow tracking ECL moving southward along the NSW coastline bringing heavy rain, strong winds and high sea levels due to the event coinciding with a king tide. The unusual wave direction of east-north east exacerbated erosion impacts due to event predominantly affecting bays which receive little erosion. For this reason, the event received significant coverage due to the impacts on the coastal zone which normally receive minimal erosion impacts from storms e.g. Currarong in Jervis bay as seen in Figure 6 where steep erosional scarps occurred.

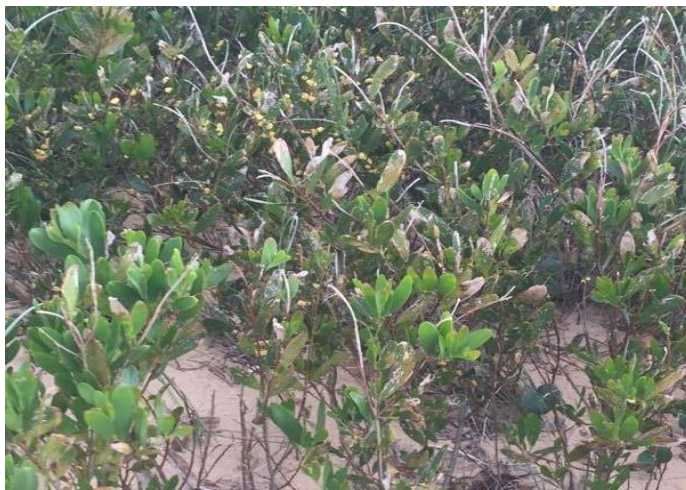
Acacia Longifolia subsp. *Sophorae*: This species is commonly known as Coastal wattle. It is a native shrub and ranges in height from 0.5-5m.

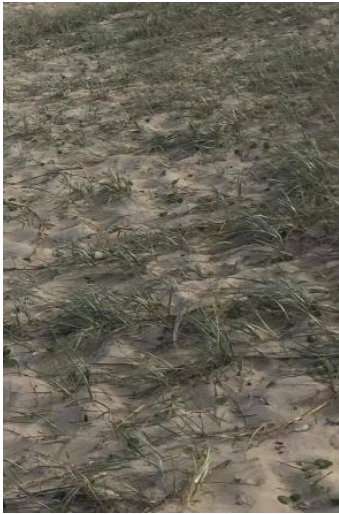
Spinifex Sericeus. This species a pioneer vegetation species commonly known as spinifex.

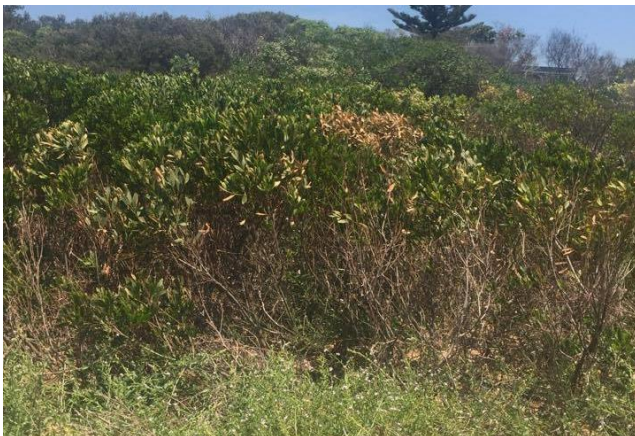
Lomandra Longifolia. This species is a native shrub and is commonly known as Coastal teatree. It ranges in height from 1.5m to 6m.

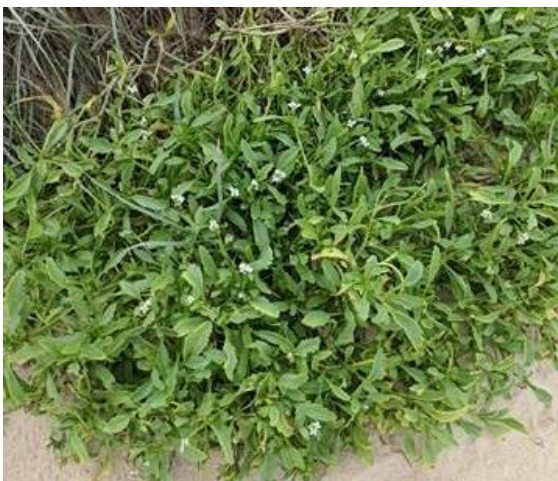
Cakile maritima. This introduced shrub is commonly known as European sea rocket. It can range in size from 0.5m to 1m.

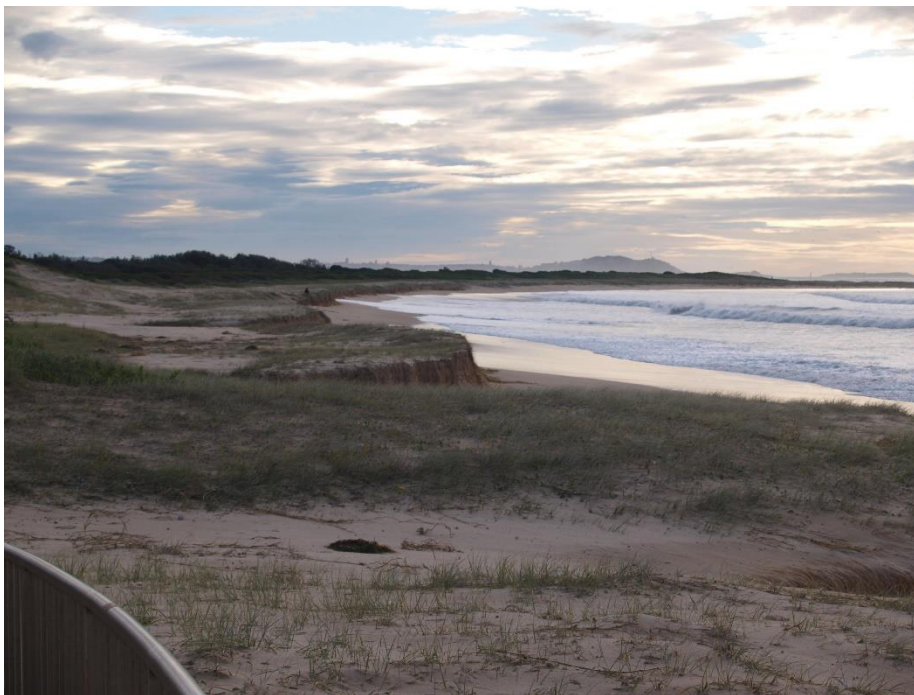
Figure 11. Warilla beach looking north from the centre of the beach on the 7th of June. Note the erosional scarp present which decreases in height towards the northern end. (Photo by Daniel Weicek, OEH)

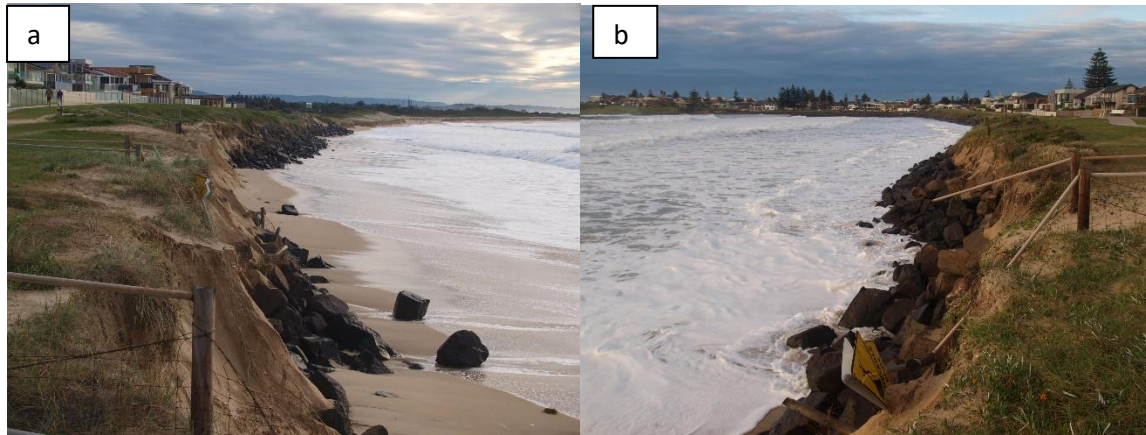
Figure 12 Storm impact upon the southern end of Warilla beach. Note fence damage in a) and undercutting of walkway and rock wall exposure in B). (Source: Daniel Weicek OEH)

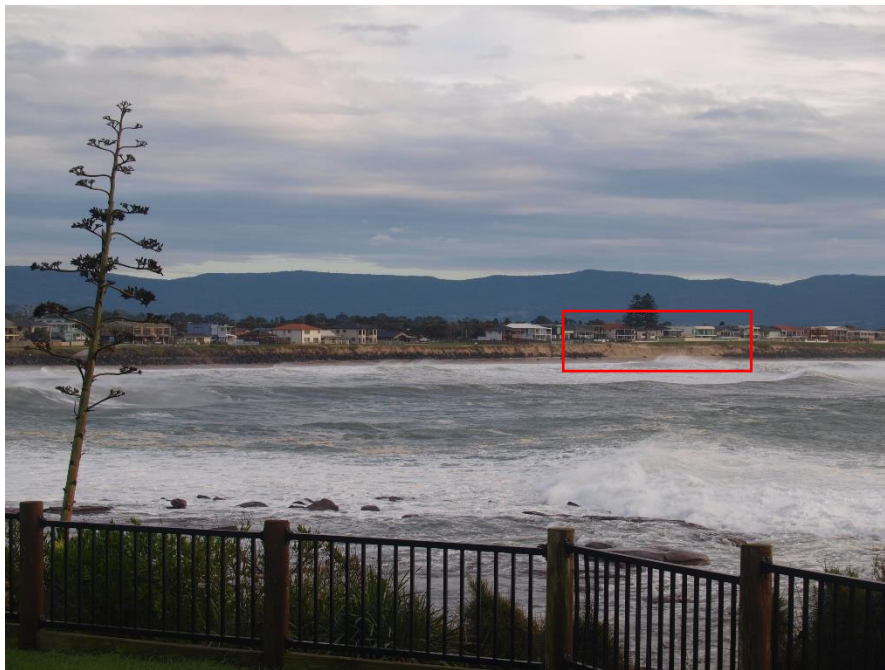
Figure 13 Southern section of Warilla beach on the 7th of June highlighting large wave conditions. Note the red box outlining a missing segment of the rock wall which may highlight a hotspot of erosion.

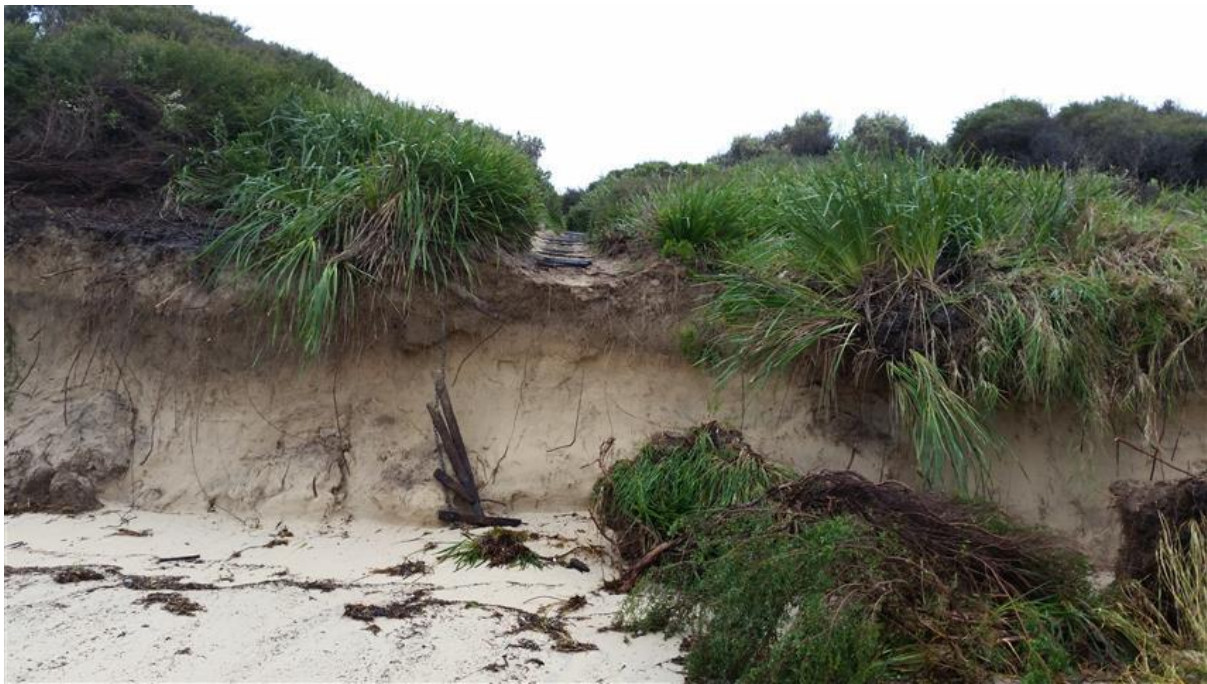
Figure 14 Walkway undercutting and destruction at Currarong beach (6th of June 2016). Note vegetation removal and slumping upon the Scarp. (Source: Ray Massie, 2016)

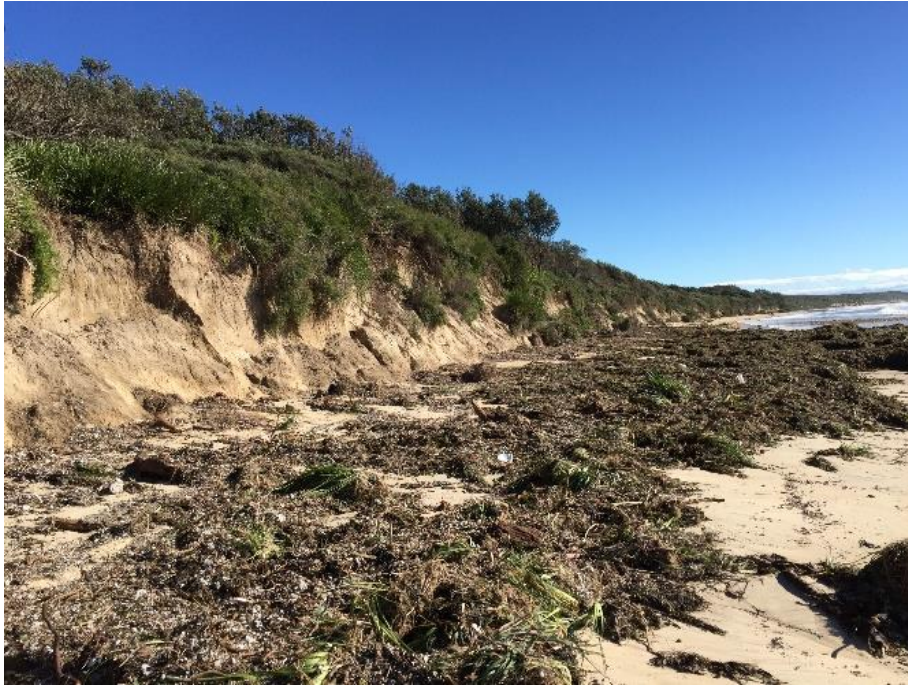
Figure 15 Vegetation removal and scarping at Currarong on the 8th of June (Source: Aimee Beardsmore, 2016)

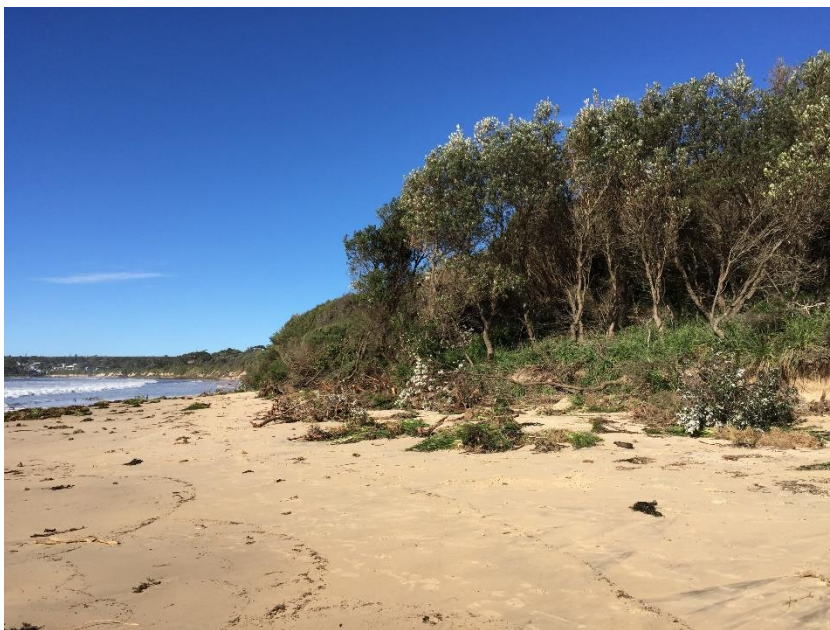
Figure 16 Note established trees have been removed during erosion and are placed along the berm on the 8th of June (Source: Aimee Beardsmore, 2016)

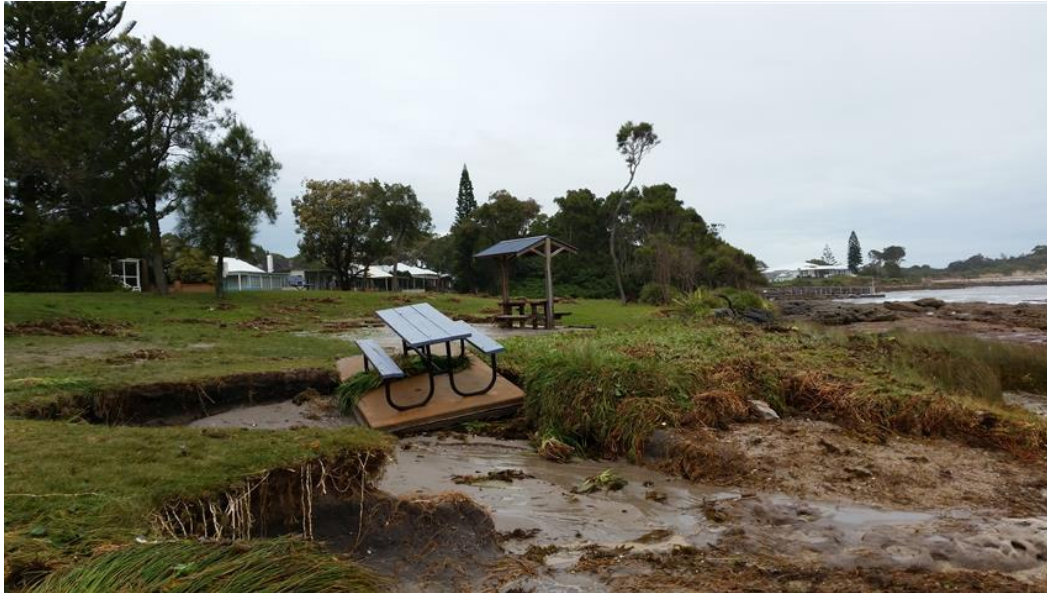
Figure 17 Erosion at southern end of Currarong displacing recreational infrastructure (tables) and placement of eroded vegetation on June 6th. (Source: Ray Massie Shoalhaven Council, 2016)

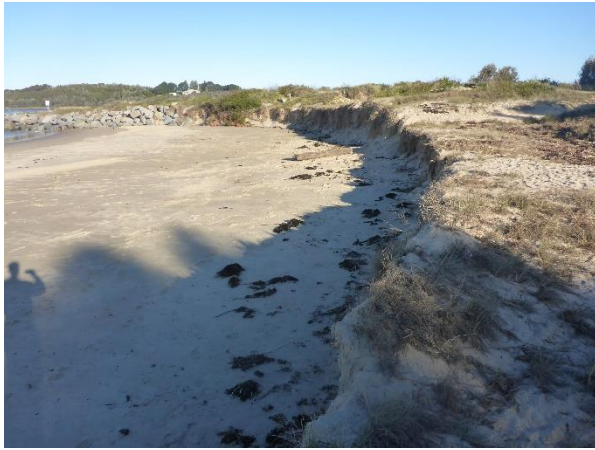
Figure 18 Scarping along the southernmost section of Bengello Beach. (Daniel Weicek, OEH 2016)

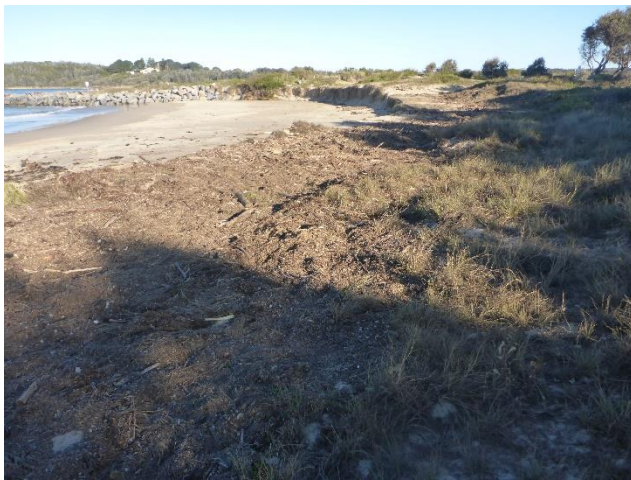
Figure 19. Vegetation transported and placed during high wave conditions.(Source: Daniel Weicek, OEH 2016)

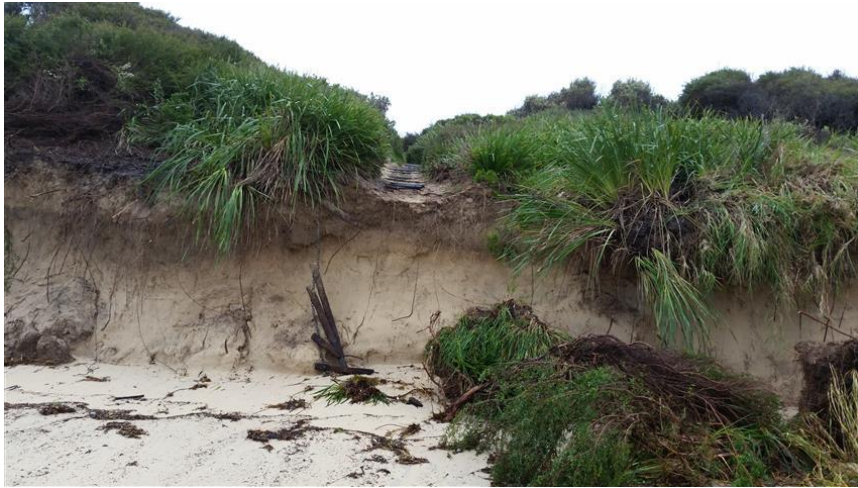
Figure 45 Walkway undercutting and destruction at Currarong beach (6th of June 2016). Note vegetation removal and undercutting. (Source: Ray Massie, Shoalhaven City Council, 2016)

(Figure 45 and 46). This remediation work occurred at only a section of the beach near the intersection of Worrigee road with Warrain Crescent, where scarping was most severe.

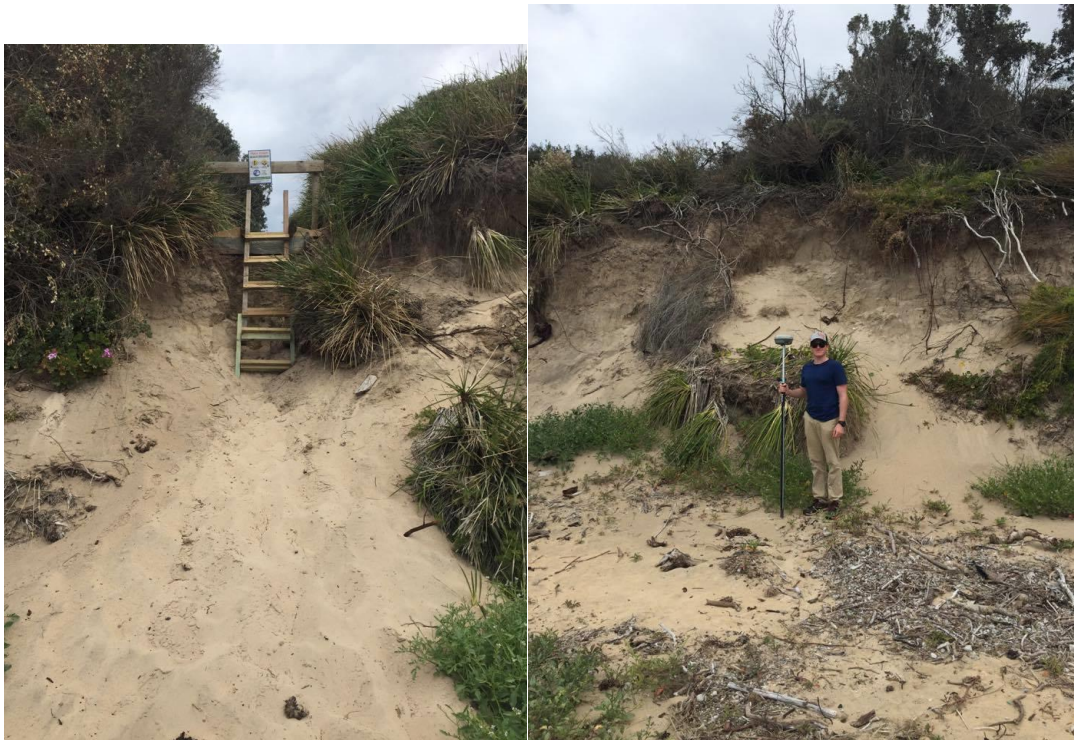
Figure 46 Scarp slumping on October 19th at Currarong. Note loss of vertical cut and accretion of sand at toe of dune (Photos taken by Author)

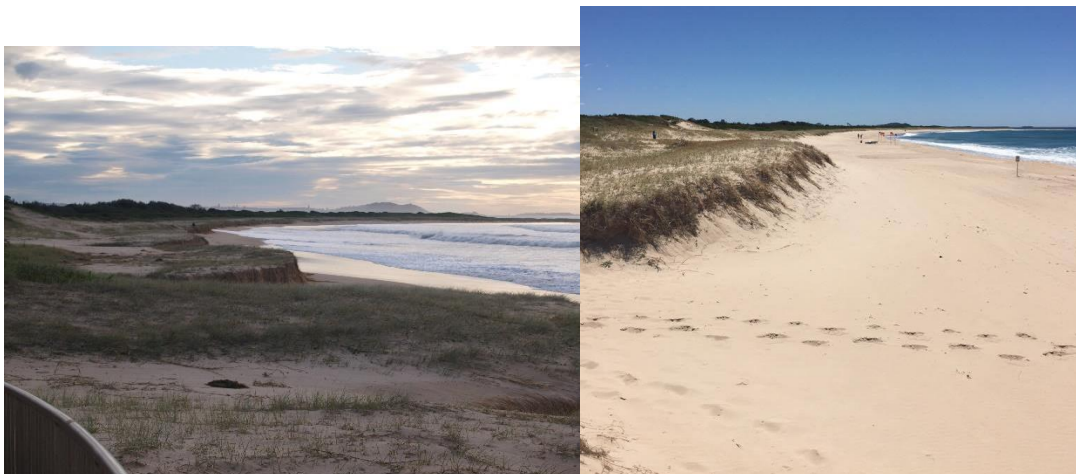
Figure 47 A) Warilla beach looking north from the centre of the beach on the 7th of June. Note the erosional scarp present which decreases in height towards the northern end. (Photo by Daniel Weicek, OEH); B) Dune scarping at Warilla beach in October. Note the vertical cut present in A) has become less pronounced with pioneer vegetation forming at the toe of the dune (photo taken by Author, October 19th 2016).

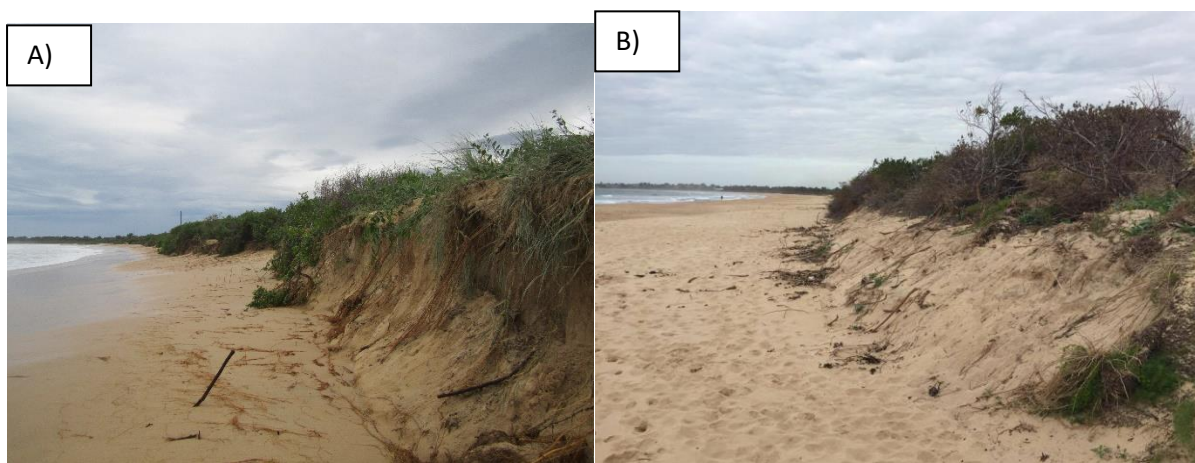
Figure 48 A) Woonona beach looking south on June 6th (Photo source: Aimee Beardsmore, OEH, 2016). Note vertical scarping. B) Slumped scarp on September 8th 2016 (photo taken by Author)
